MEETING DOCUMENTATION

PROJECT: Dixon County LEC – Citizens Committee Meeting #3

LOCATION OF MEETING: Thurston County Jail – Pender, NE

PROJECT NO.: 222701 **DATE:** July 11th, 2022 **TIME:** 6:30 PM

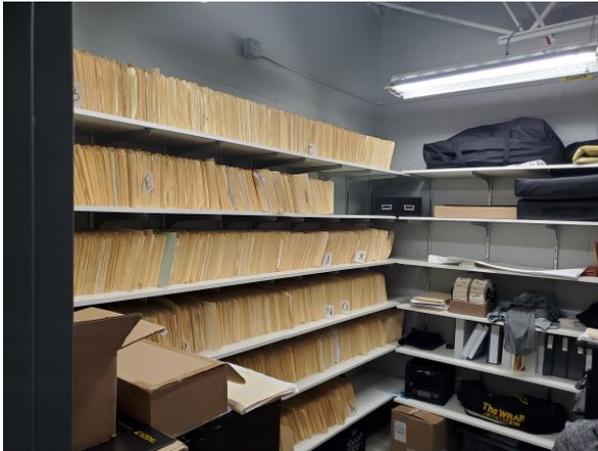
Figure #1. Records Storage

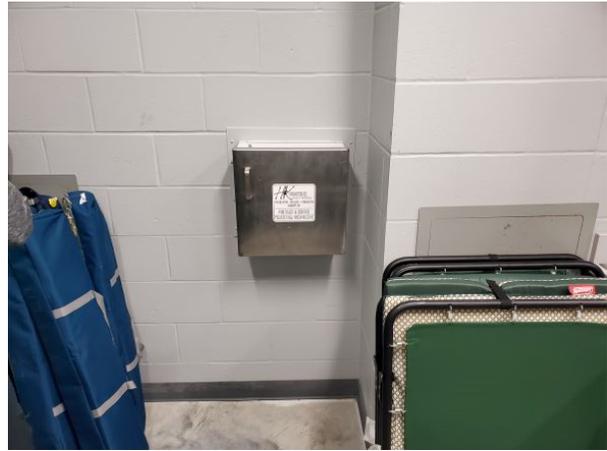
6. The tour group next saw Inmate Intake, Showering, Change-out, and Records and Inmate Property Storage areas. Julie was appreciative of all the storage areas available in the new Jail, and indicated a preference for the tub-type Property Storage for each inmate. Julie shared an anecdote of how the Inmate uniform pass-thru door (16-inch square +/-) between the clothing storage and shower area had been recently welded shut, ever since one individual broke through, and crawled from one room into the other (see figures #1 and #2 below).

Figure #2. Welded clothing transfer between Storage and Intake Shower Room

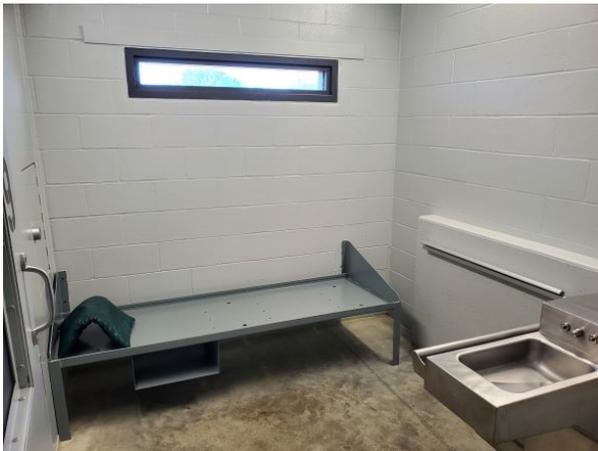
7. There is a negative pressure Holding Cell, for holding inmates with infectious diseases, such as TB, Aides, or Covid, which also contains an outside window, allowing it to serve as a longer-term holding cell (see figure #3 below). Although the Holding Cell capacity was around eight, Julie also stated that she wished for additional negative-pressure Cells.

Figure #3. Negative Pressure Holding Cell with window

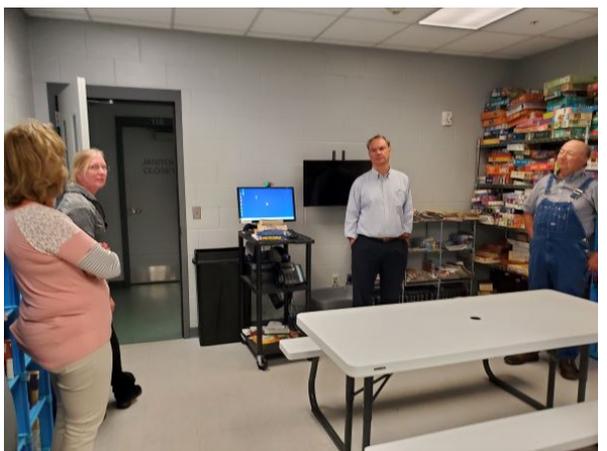
11. The group was also shown a Meeting Room/Library, which we learned had also been set up to allow video Court procedures, and occasional religious services. The book collection seems significant compared to other county jail libraries (see figure #4 below).

Figure #4. Meeting/Multi-purpose Room with Video

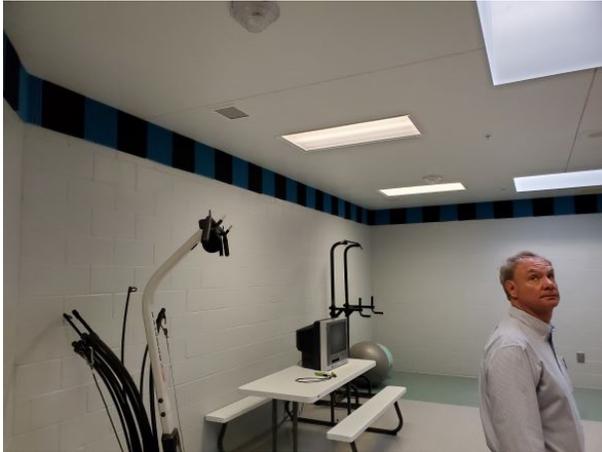
15. The group also saw the Indoor Recreation area, which was served by sky-lighting, fresh air intake, and contained an exercise machine (see figure #5 below). Staff has apparently complained about the sound reverberation in this room, so a sound-absorptive material had been partially installed at the ceiling perimeter.

Figure #5. Indoor Rec area with Sky Lights and Sound-deadening material at the ceiling

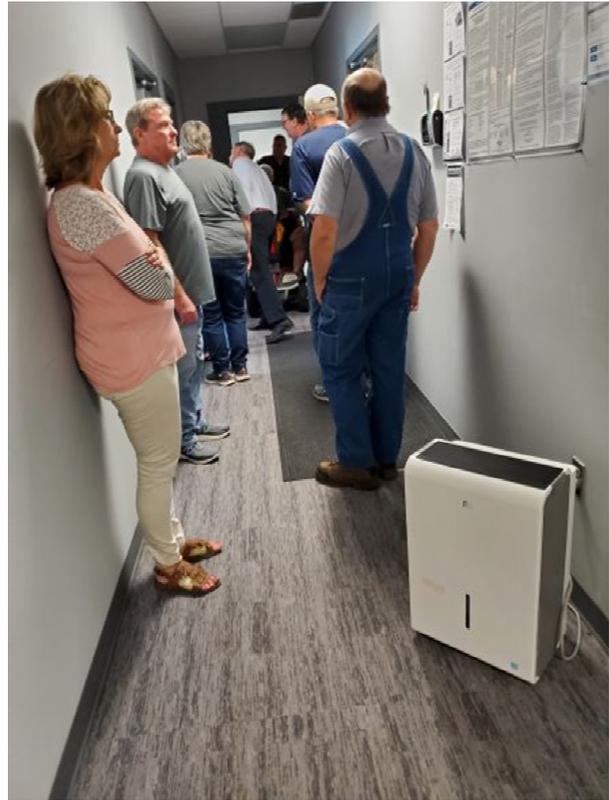
20. There was a comment offered on several occasions regarding the existing HVAC ductwork being undersized for proper dehumidification of the Admin spaces; consequently, there were supplemental dehumidifiers plugged into receptacles in the Corridors (see figure #6 below)

Figure #6. Supplemental dehumidification in the Administration area Corridor
